Tip: Strange Happenings Log Part 1

Start Date: 27-02-07, New 16-01-2024

Strange Happenings Contents

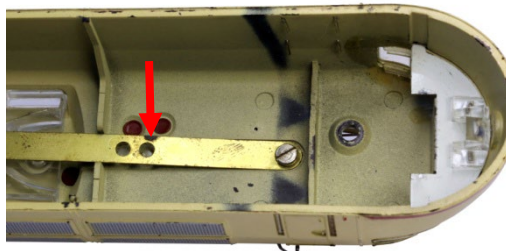
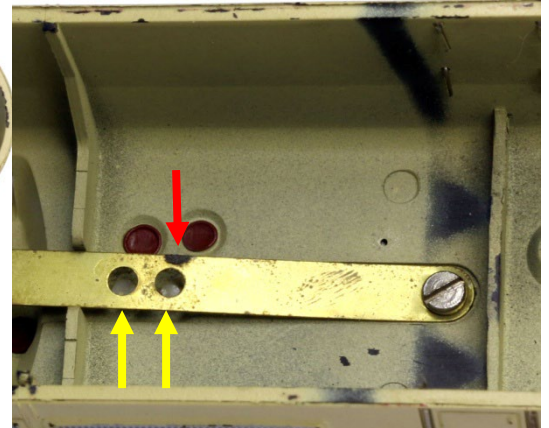
There is an electrical arc burn on the pantograph connection strip see red arrow. When the motor bogie turned it shorted on the bowed strip because the two plastic holding supports had broken, see yellow arrows.

I removed the screw holding the metal strip and applied hot melt glue to the area around the plastic supports and bedded the strip into the glue. I replaced the pantograph screw then the body shell and once again tested the locomotive. The problem was fixed.

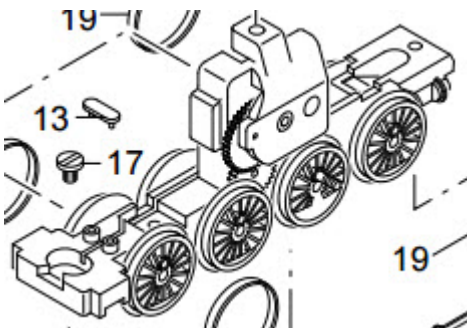
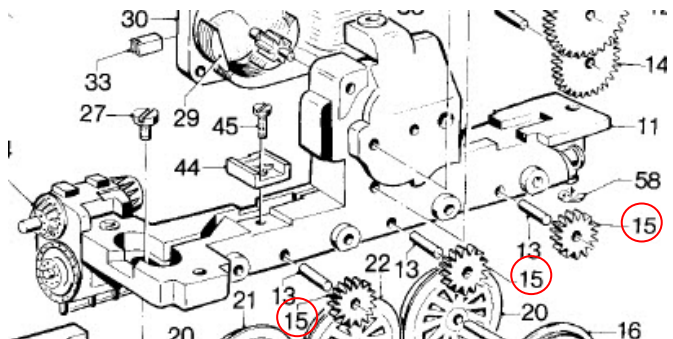
Problem 1: - After a close examination of the powered drive wheels I could see that the gears between the drive axles had damaged teeth which jammed when the wheels were rotated. I looked at the explosion diagram and discovered the drive gears aren't specified (see diagram on the left).

The two gears on the left are damaged and the gear on the right is new.
This is the first time I have encountered this problem on a new locomotive.

I looked at older explosion drawings for the Borsig locomotive and discovered item 15 was the required gear with part # E237930. I hope this trend of not showing all parts from Märklin doesn't continue.

Solution 1: - I replaced the gears and now the locomotive runs like new.

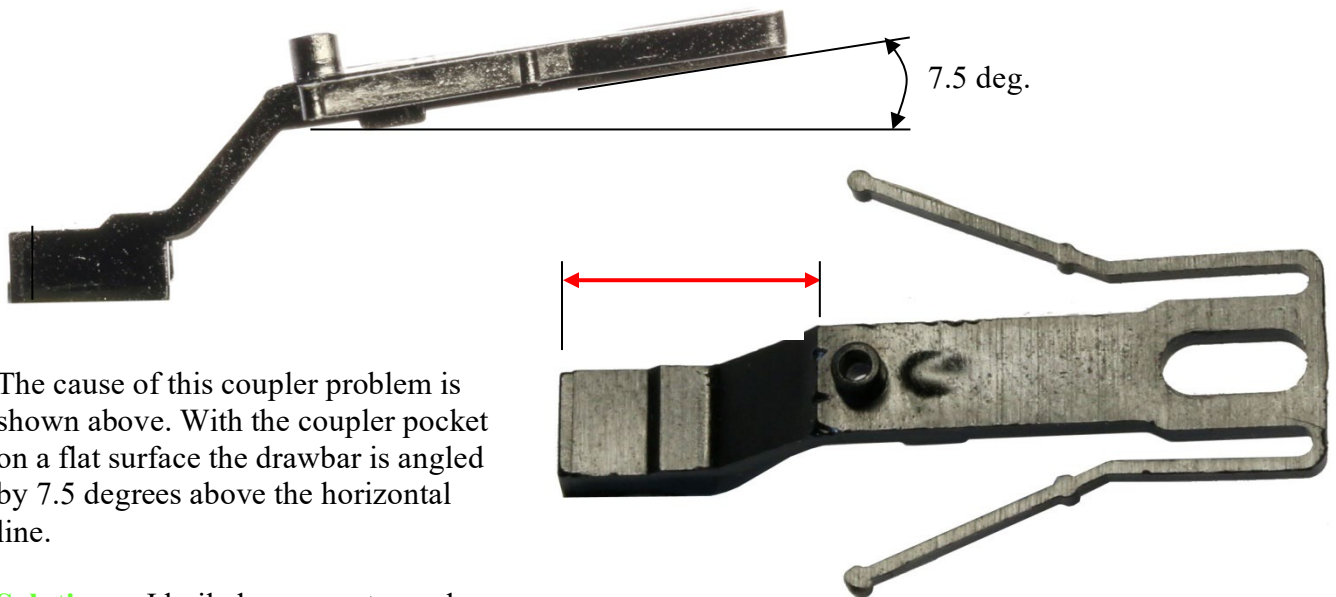
The cause of this coupler problem is shown above. With the coupler pocket on a flat surface the drawbar is angled by 7.5 degrees above the horizontal line.

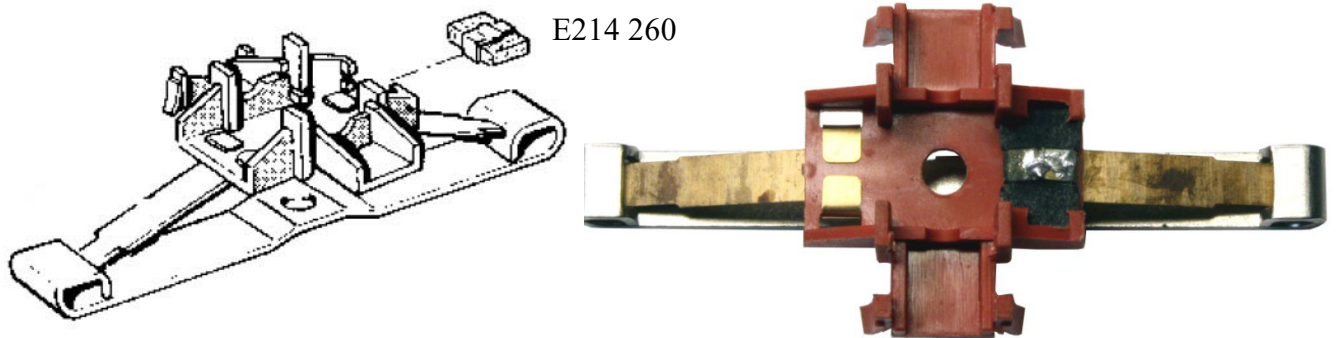
Problem: - I was trying to change some CV values for this locomotive and it failed. When the locomotive was placed on the layout it would run for a while then stop at random. If I raised the tender then replaced it back on the track it would run for a short distance then stop once more. This behaviour indicated to me that the electrical connection to the collector shoe was at fault. I unclipped the collector shoe and I could immediately see the problem was a loose solder contact plate (E214 260)

Solution: - I slid the contact plate out of the slot in the collector shoe (E280 270) and prised up the collector shoe holding lugs a small distance then refitted the contact plate carefully and made sure the fit was very firm. I soldered the wire back on and re clipped it to the tender bogie. The locomotive once again ran very well.

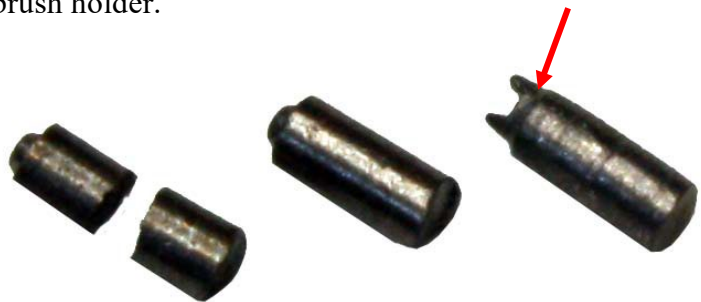
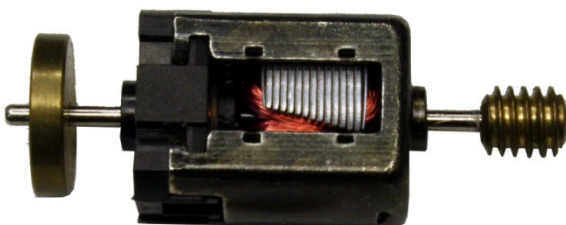
The photo shows the broken brush (left), the middle brush is original and the (right) brush is my manufactured one and I made sure that the spring would also fit on the end (red arrow).

The motor at the left has the brush holders, springs and brushes shown below. Once the locomotive was reassembled it ran like a dream.

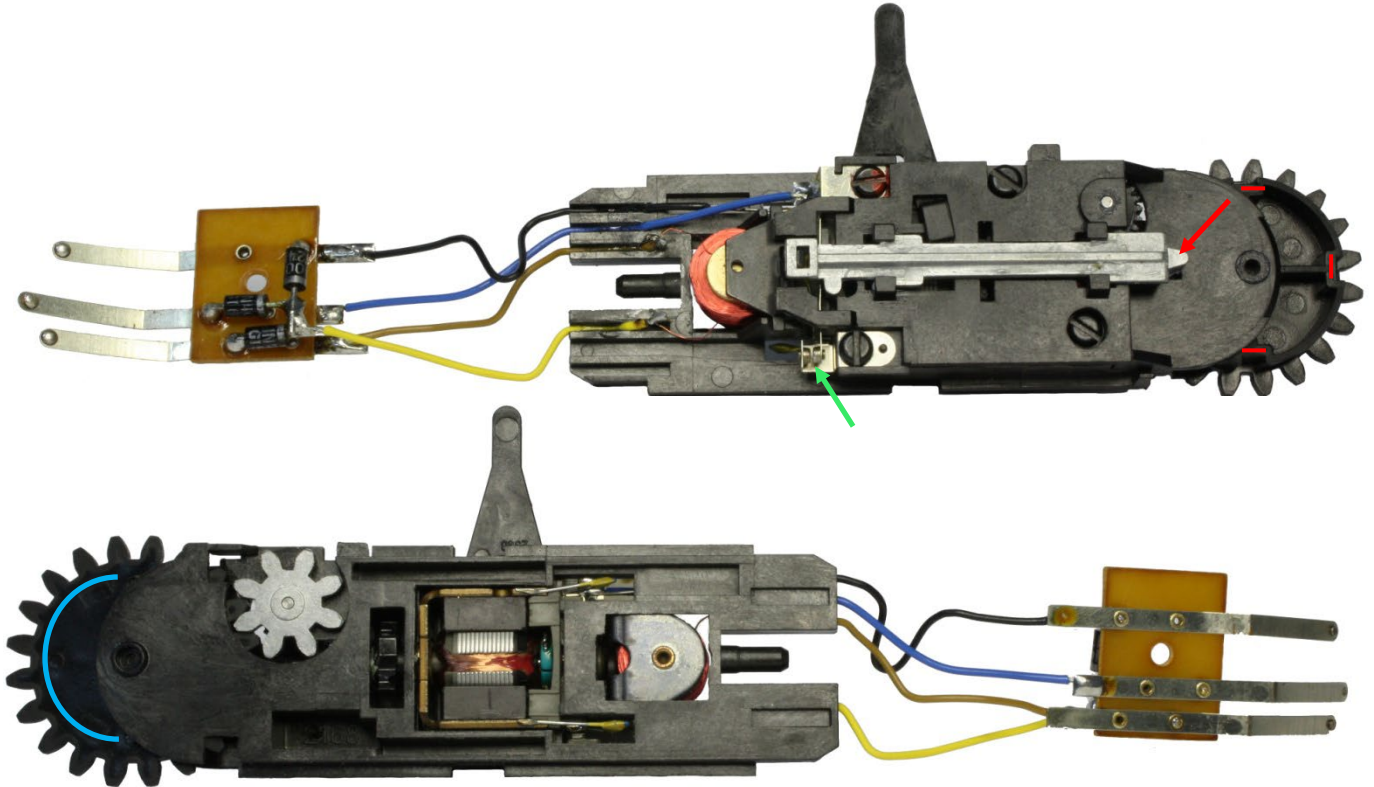
In the top photo showing a default neutral position I found that the index lever (red arrow) was pushed back closing the motor contacts (green arrow), because the indexing indents on the large gear shown as red lines were rotated away from the neutral position. This caused the decoder to show a fault because the motor contacts were closed when turning on the power to the turntable.

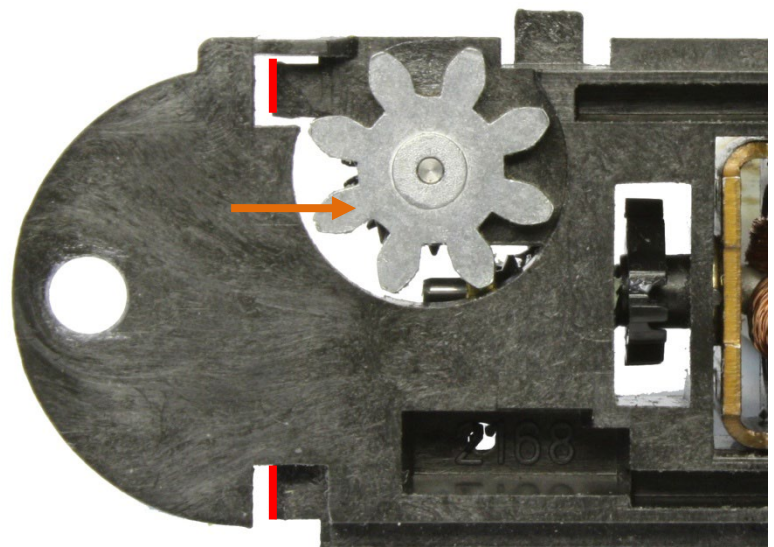
On very close inspection I found the large gear teeth caught on the edges of the housing (red lines) in the photo below

Using a fine needle file I chamfered the highlighted edges.

I then retested the large gear, success at last and with no more jamming of the large gear I carefully reassembled the motor drive housing.

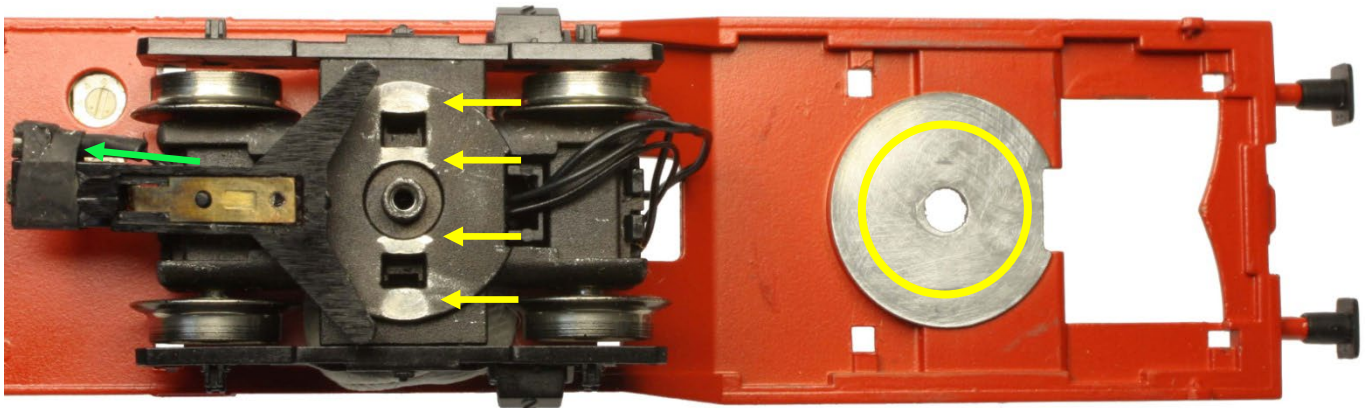
Problem: - The Cargo Sprinter would jerk or halt when driving over the 2275 double slip points when the direction was set straight across. The Cargo Sprinter is driven by the front bogie and all four wheels have a rubber tyre so there is no good ground connection at this end. At the collector shoe end all wheels, act as the ground contact. The problem is that with the wheel spacing distance of approximately 30mm it is just too small a distance to get over the non-electrified rail sections of the 2275 double slip when set to the straight direction.

I removed the bogie at the collector shoe end and cleaned the contact points (see yellow arrows and circle)

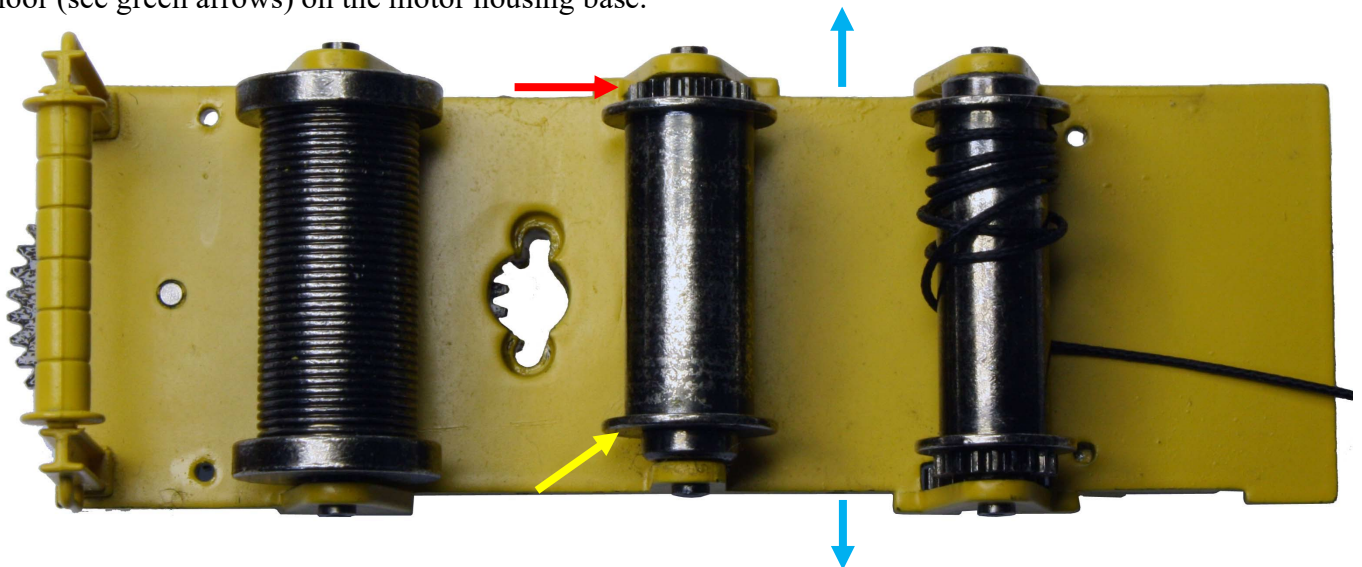
In the photo above the only grease visible was going hard and I could also see wear marks on the left gear pinion which I think is rubbing on the screw that holds the PCB and/or the mark on the body for the cabin floor (see green arrows) on the motor housing base.

The photo above shows the plastic cable drum protectors have been removed by carefully pulling them in the direction of the (blue arrows) shown. I decided that the middle drum shouldn't be removed as the mounting pins were a press fit into the drum.

I removed the hook cable by cutting off the end where it is fixed to the middle take up drum at the (yellow arrow) location. I unwound the loose end until I got to where it had jammed between the gears (red arrow). Holding the hook cable on either side of the drum gear I pulled the cable away from the gear and rotated the bottom gear at the same time and the cable came free. There was very little damage to the cable so I inserted it back into the hole at the (yellow arrow) location and melted the end with my soldering iron so it couldn't slip back through the hole. Problem solved.

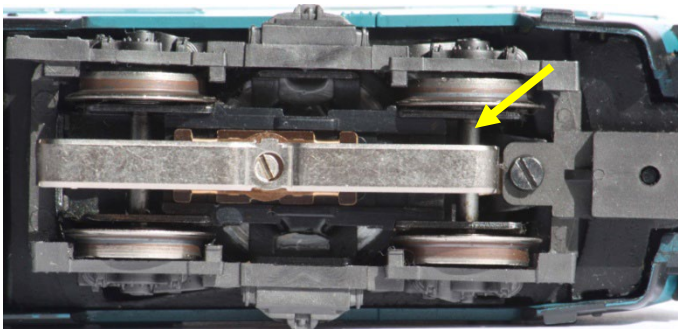
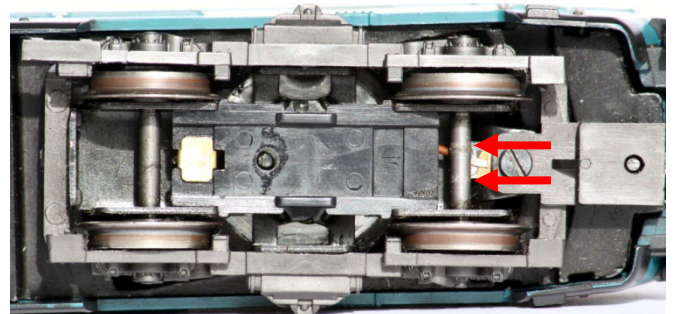
The correct collector shoe 7164 for the locomotive shown above, ends directly above the axle (yellow arrow) and was shorting on the axle at two places shown by the red arrows, you may be able to see the arc burns on the axle.

I removed the 7164 Collector shoe and replaced it with a 7185 Collector shoe and the problem short circuit was fixed.

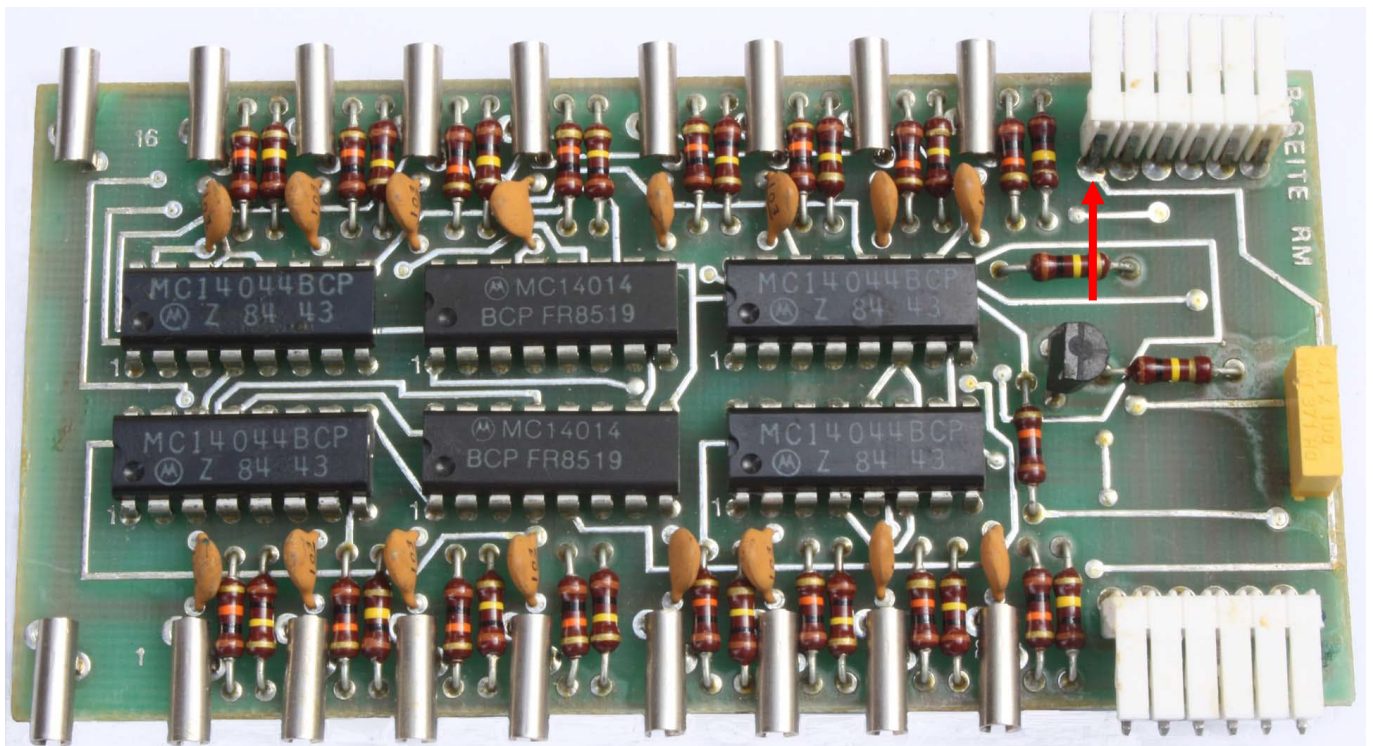
Problem: - While running my trains using a computer with RR&Co software, I started to have trains fail to stop or slow down. On closer inspection I noticed that the last s88 decoder in the data chain wasn't responding at all. Once I had removed the s88 decoder I discovered that the "Dataout" pin on the top connector that feeds back from the shift register to the central unit was black (see red arrow). Over the years the flux on the PCB had migrated onto the pin and tarnished it enough that it would not conduct.

Solution: - I removed the tarnish from the pin using some contact cleaner then polished the pin with some 1200 grit wet and dry sand paper. I then tested it to make sure it was working then reinstalled it back on my layout.

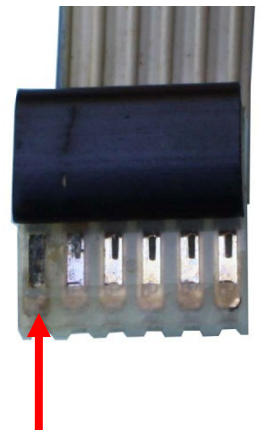
Today I had to replace the data cable that connects between s88 units because on closer inspection the corrosion had also migrated to the cable connector pin (see red arrow)

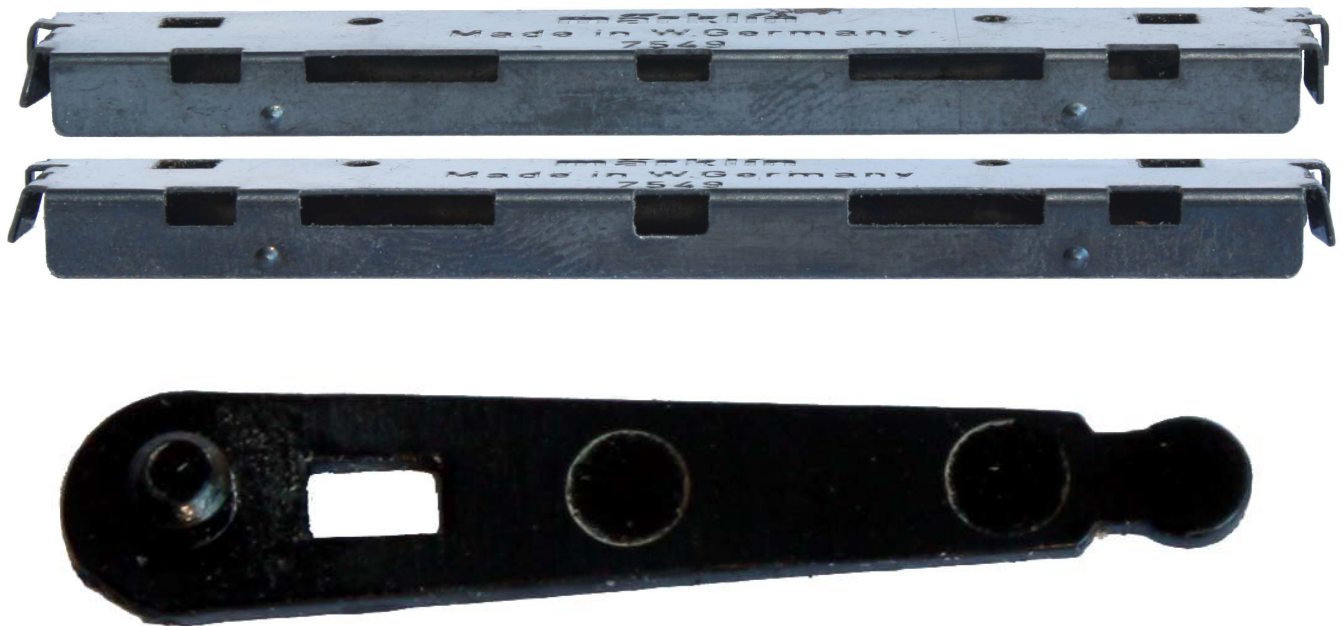
Problem: - I was getting derailments at points which sounded normal when switched but failed to throw the full distance. On closer inspection I found the point motor was the culprit as it was very stiff or in some cases it would jam half way through its throw. The cause was the actuator was binding with the metal body of the point motor.

The top metal body is before modification and the body below it shows that the middle hole has been enlarged by 0.5mm in the downward direction, compare with the other holes to see it's not much. Next, I had a good look at the actuator and noticed the flash at the location of the round ejector marks. Using 1000-1200 grit wet and dry sand paper I removed all the flash and reassembled the point motor. For good measure I also puffed in some Labelle 134 Teflon lubricating powder around the actuator and the result was a like new point motor that switched with a very positive click. As I service my point motors to clean the electrical contacts, I'll make sure I also do this modification.

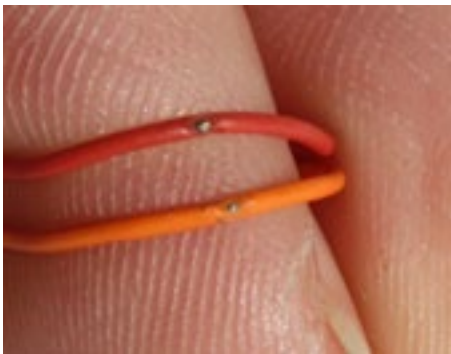
Problem: - The interior lights had failed to switch on with the F1 function and the railcar ran with a jerking motion. Once I had removed the body shells of the locomotive, I found that two wires had short circuited with the drive shaft on the driving bogie. The insulation on the wires had been removed by rubbing on the rotating drive shaft. The red wire was the F1 function and the orange wire is the + supply for all lights.

Solution: - First, I replaced the damaged wires and the AS3 transistor on the circuit board. To stop the motor shaft rubbing on the wires, I cut some clear plastic into a rectangle 21.5x9x0.3mm (LxHxT). Because the plastic is longer than the space it was inserted into it formed a nice bow, allowing the motor shaft on the driving bogie to swing freely and form a barrier so the wires were protected. I also used another plastic strip at the motor end to create the protective barrier between wires and motor shaft.

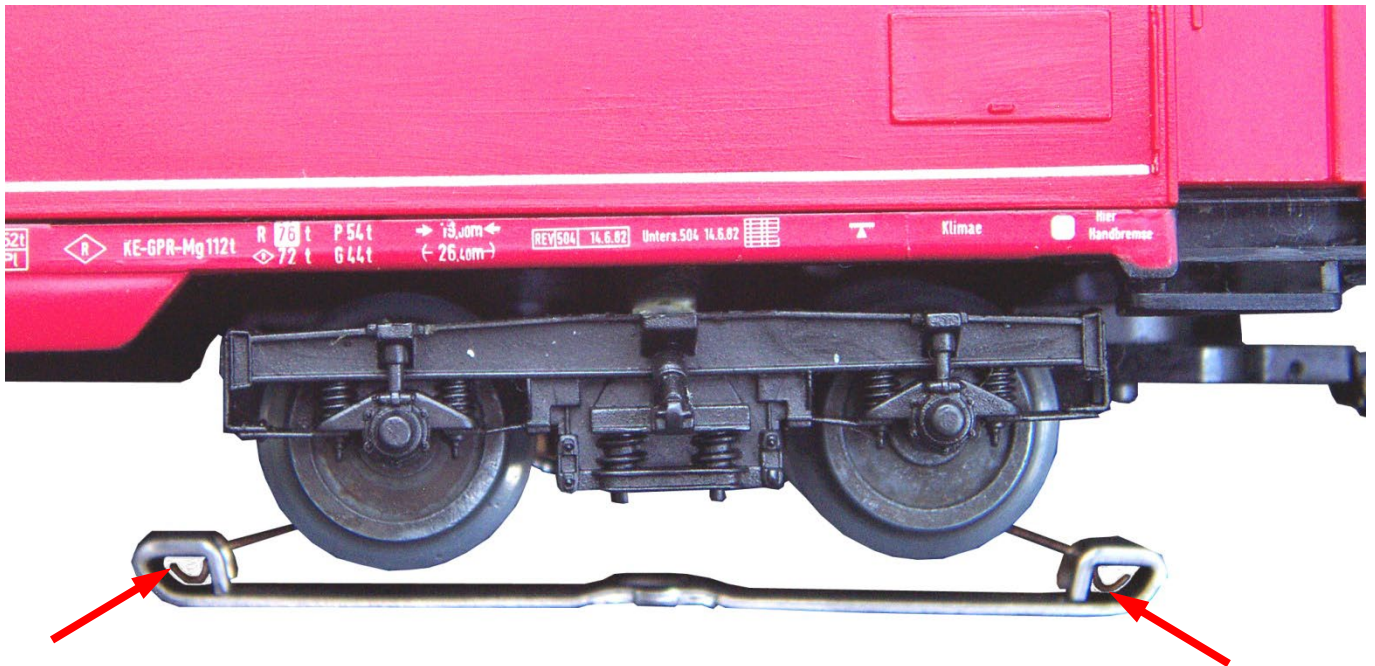
Problem: - After much trial and error, I determined that the collector shoe was to blame. The bronze spring had caused arcing burns to the slider of the collector shoe.

Solution: - I used Electrolube PL-64X from Peco Lectrics between the spring and the slider of the collector shoe (see red arrows), this ensured a continuous electrical connection. It may be interesting to note to use this fix where ever a collector shoe is required that has been used for a long time.
