Tip: Strange Happenings Log Part 1

Start Date: 27-02-07, New 16-01-2024

Strange Happenings Contents

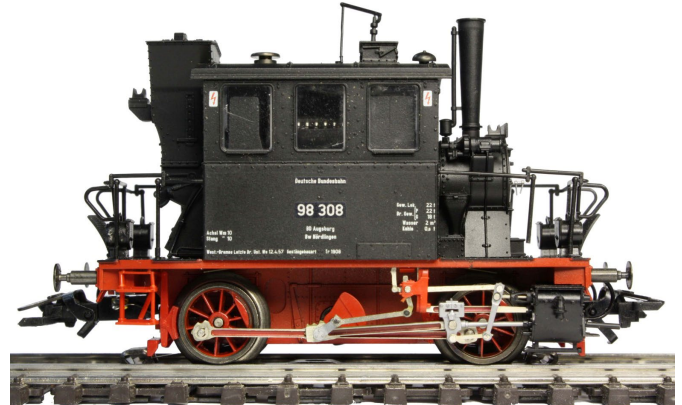
Problem: - From time to time I get out my locomotives I have in storage and give them a run around the track to ensure they still run and function well. In January 2009 I was testing the 3687 locomotive and after a few minutes of nice running the locomotive suddenly became very jerky. I disassembled the locomotive and found that a brush had broken in half. On the spare part sheet supplied with the locomotive there is only a complete motor listed as part number 371300, so I wrote to Märklin Service asking for the part number for the brush and I got a quick reply that they could supply the complete motor only, for a price of 49.95 EUR plus postage or I could send the locomotive back for a service. Now living in Australia this seemed to me to be a very expensive solution for such a simple problem, I decided not to do indulge in this expensive option and just put the locomotive back into storage.

The photo shows the broken brush (left), the middle brush is original and the (right) brush is my manufactured one and I made sure that the spring would also fit on the end (red arrow).

Solution: - Since I have just completed upgrading my layout with the 'Diode Trick' I decided to test all my four wheeled small locomotives to see if I had made any improvement to their running. I chose the 3687 Locomotive with the broken brush by mistake but instead of putting it aside I decided that I would have a go at manufacturing a replacement brush to get the locomotive running once more. I chose a 60146 standard Märklin brush and held it in a pin vice which I then inserted into the chuck of a small drill. With the drill rotating at a slow speed, I used a small flat needle file to reduce the square shaped brush to a

new round brush that would fit into the brush holder. I had to rotate the brush 180 degree in the pin vice and repeat the process for a nice fit into the brush holder.

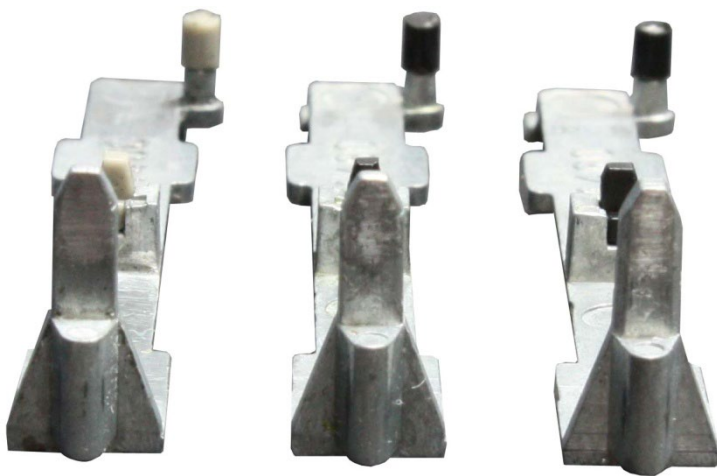
1. Original Fleischmann (far left)
2. Early Märklin (middle)
3. Greg's later Märklin design (right)

Before making any permanent changes to Greg's turntable mechanism I decided to exchange the index control lever with the Fleischmann (1) original. When I tested the turntable, it worked very well without jamming any more.

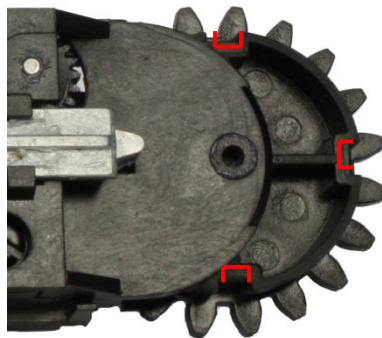
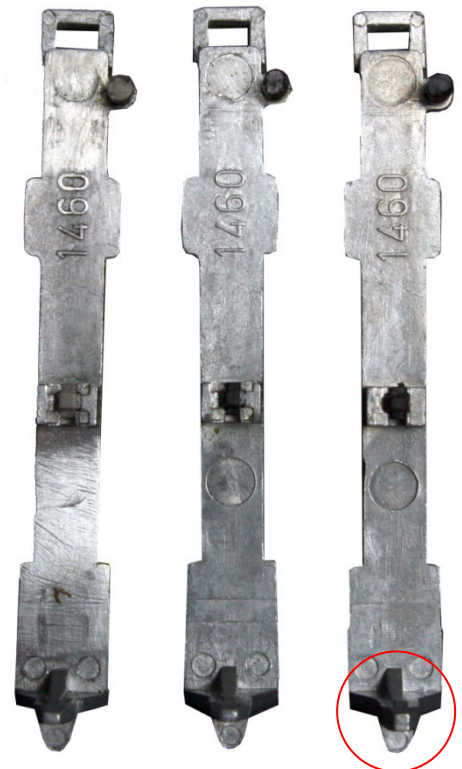
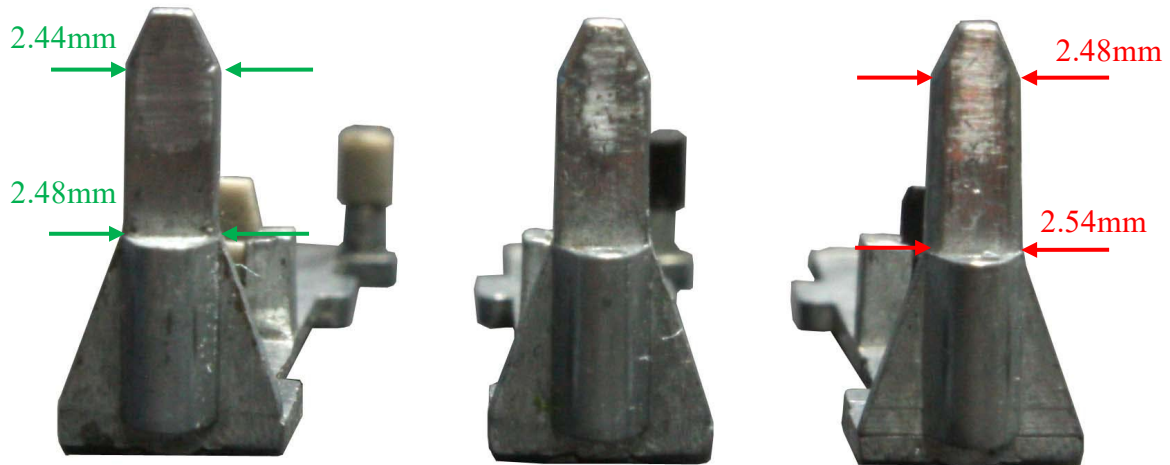
The problem index lever tongue has almost no tolerance at all and doesn't allow enough movement left or right for the index tongue to fit each time into the indexing recess and with the chamfer on each side of the tongue it helps it push out of the recess when the drive gear is turning. The motor contact remains closed and won't allow any further commands from the 7687 Decoder.

Solution: - First, I filed the front face flat to remove the chamfer on both sides of the index tongue. I then filed the sides to reduce the dimensions to match the Fleischmann dimensions (green) I also made sure no sharp edges appeared on the areas that had been filed.

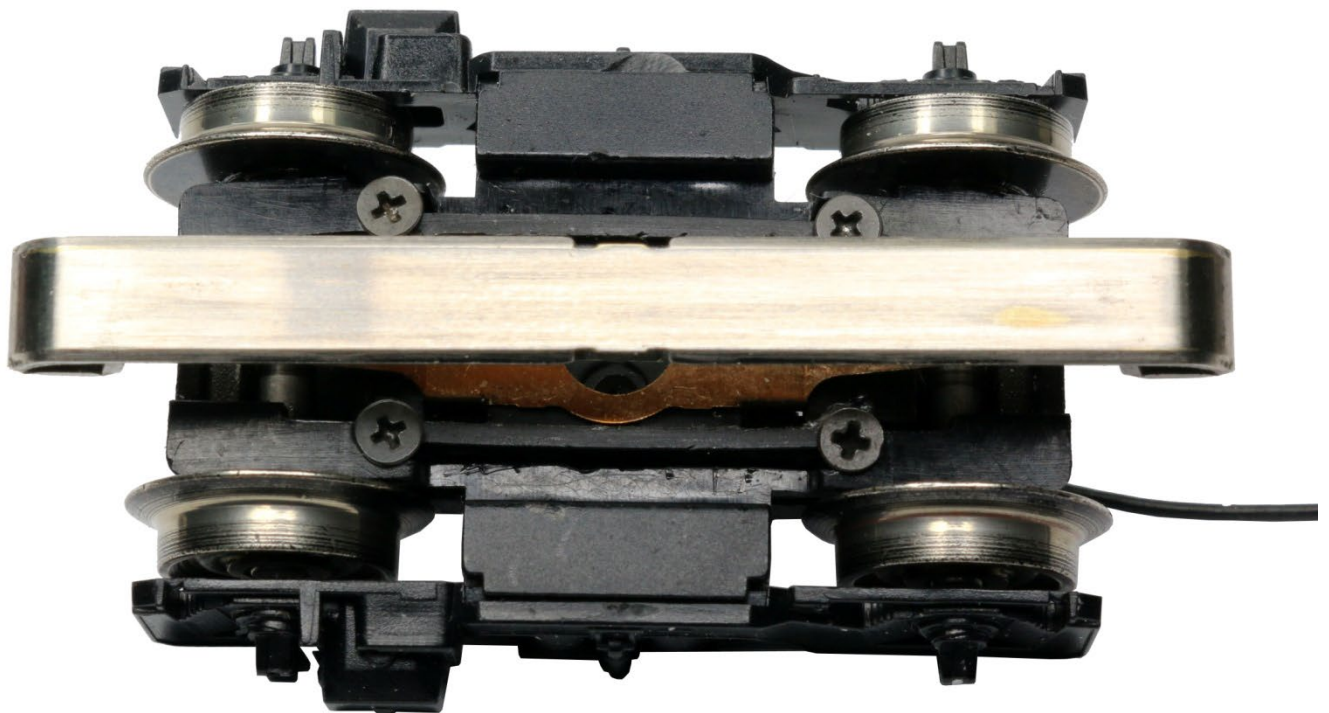
Problem: - The Cargo Sprinter started to derail over the **2275** double slips.

Solution: - As the collector shoe clips on to another plastic mount I was able to remove the mount and carefully drill 4x 1.2mm holes which allowed me to screw the collector shoe to the mounting plate.

The screws are **7599** k-track screws which have been cut down to 3.5 mm length to create a flush fit on the mounting plate.

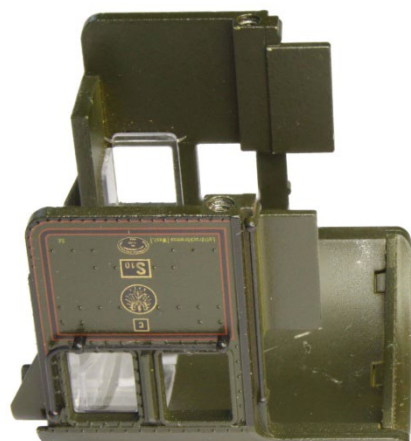
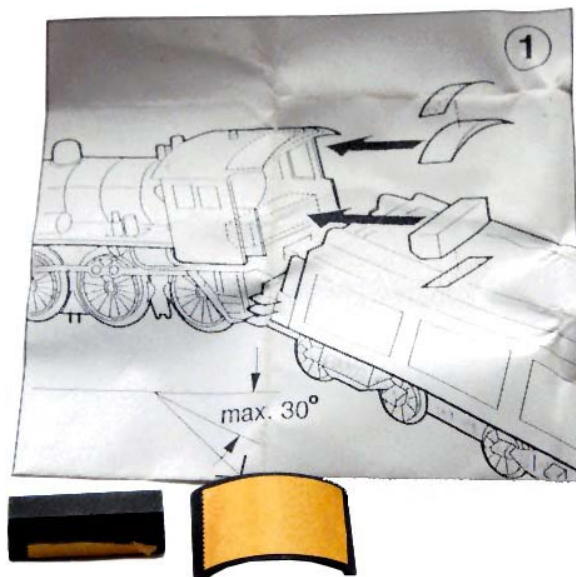
Problem 3: - The locomotive failed to pull six of the King Wilhelm II coaches up a standard 4% grade. This set was designed by Trix and sold under the Märklin name turned out to have a design flaw that there isn't enough weight over the driving wheels with the rubber tyres to allow the locomotive to successfully pull the coaches up a 4% grade.

Mäklin instructions and weights shown above.

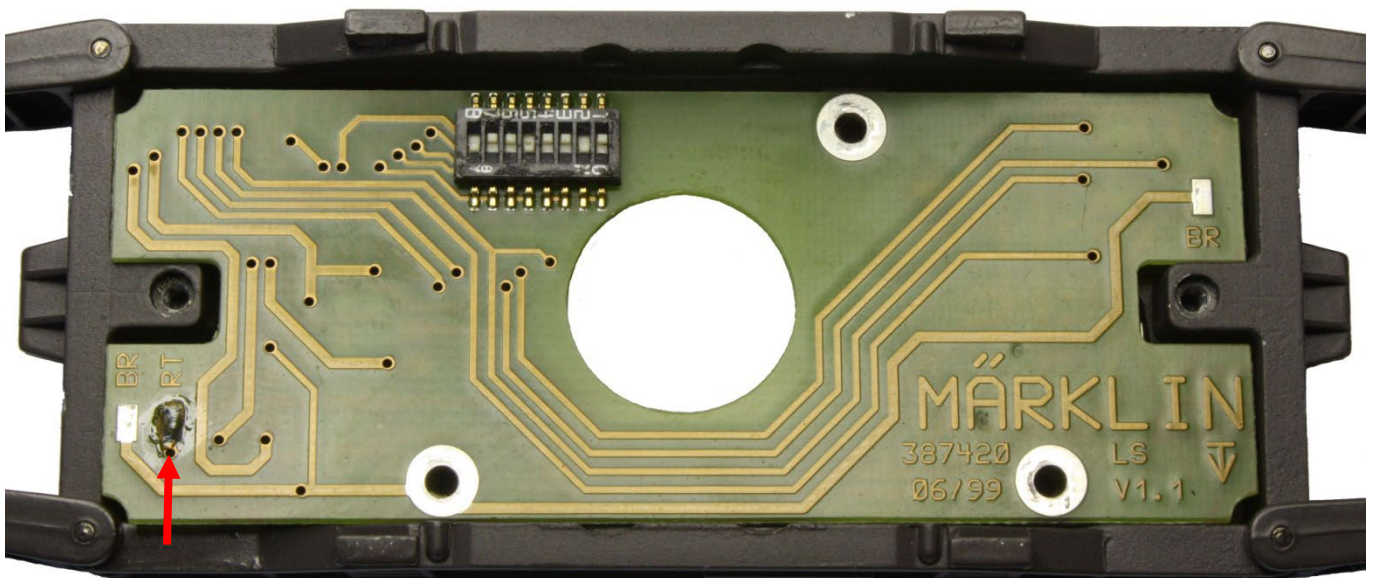
Problem: - I wanted to remove the plastic cable drum protectors so I had full access to the cable drum then I could see if I could remove the cable drum and release the hook cable that had jammed between the drive gears without cutting the cable. On close examination of the cable drum protectors, I could see that I needed to disassemble the crane because they were held in place by the body of the crane housing.

Process: - First, I removed the collector shoe. The bogie trucks were next and were easy to remove by removing the screw and **spring** for each bogie. Below the bogies is a plastic protective cover for the printed circuit board which can be carefully removed by using a fine screw driver to move the plastic cover clip by inserting the screw driver blade into the square hole and levering the clip towards the bogie screw location. With the cover removed I next unsoldered the red wire (**red arrow**) which allowed free

access to remove the three screws that hold the printed circuit board in place.

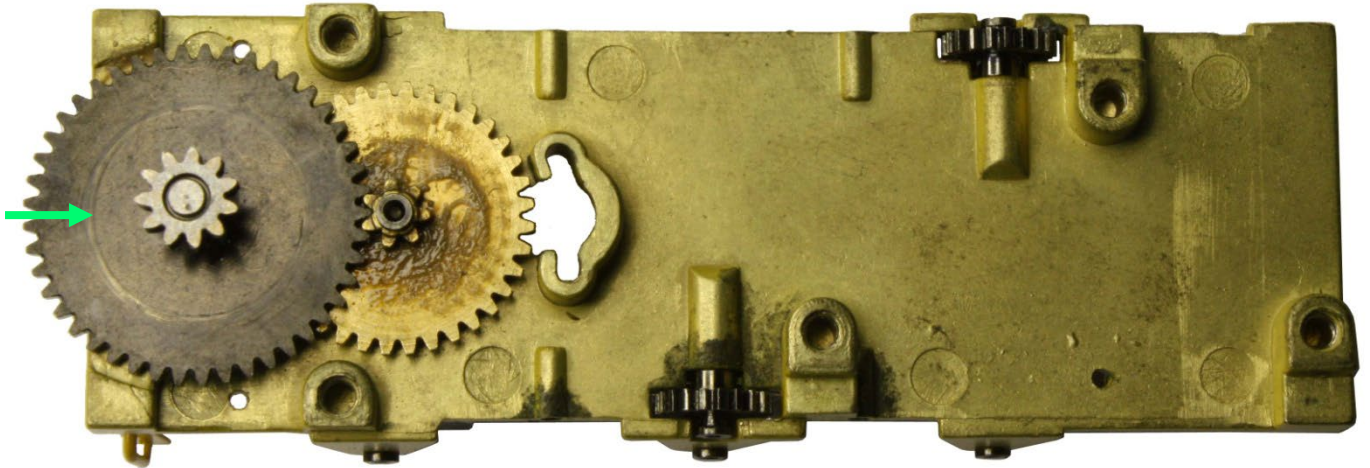
With the crane now apart the first thing that concerned me was the lack of lubrication. All photos shown where as I dismantled the crane. There wasn't any lubrication on the worm gears and mating pinion gear. The bushes that support the drive rods also lacked lubrication.

In the photo above the only grease visible was going hard and I could also see wear marks on the left gear pinion which I think is rubbing on the screw that holds the PCB and/or the mark on the body for the cabin floor (see green arrows) on the motor housing base.

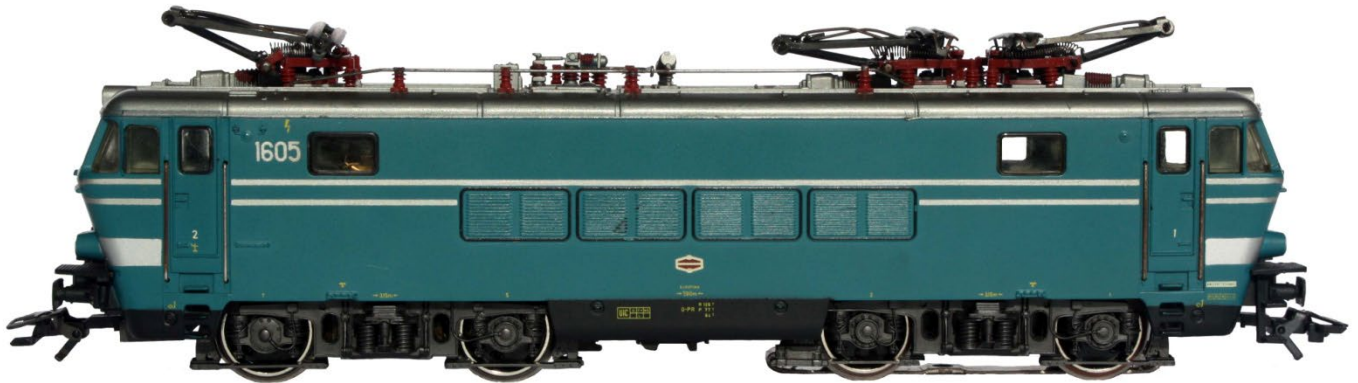
Problem: - After completing a LokPilot conversion of my 3152 locomotive I experienced jerky running when trying to profile the locomotive with TrainController. It ran ok when I ran it on the rolling test stand but not when I ran it on my layout. I found two problems, one was a short circuit and the other was a poor ground connection.

Solution 1: - The short circuit was easy to fix once I had discovered where the problem was.

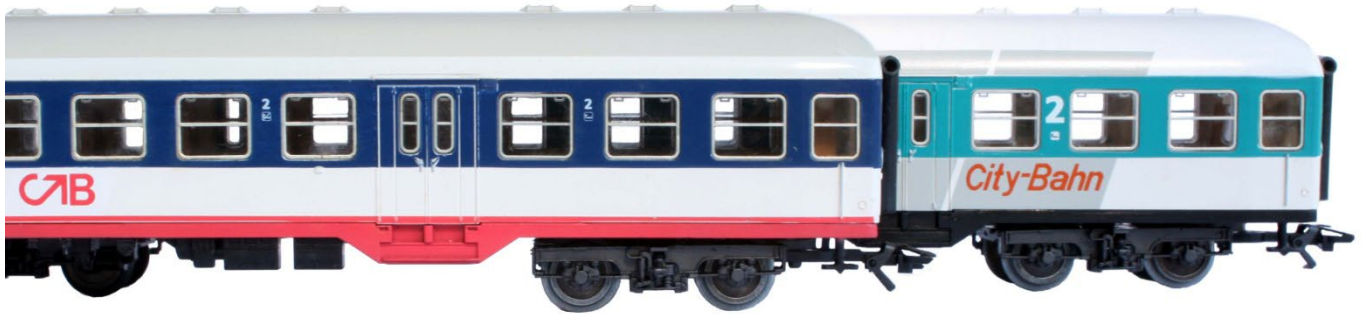
Problem: - After many years of running these coaches, they started to produce a very loud noise and on further investigation I discovered that the wheel flanges were rubbing on the underneath of the coach.

I removed the bogie assembly from the coach with a strong pull and could see where the wheel flanges had been rubbing.

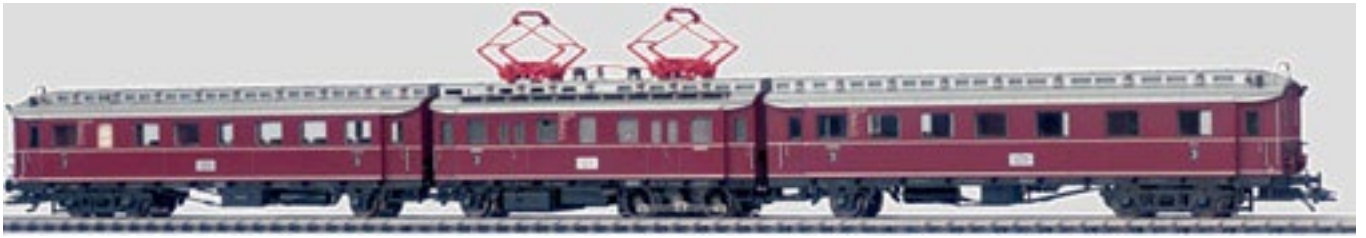
37265 BR ET87 Electric Railcar

Problem: - The interior lights had failed to switch on with the F1 function and the railcar ran with a jerking motion. Once I had removed the body shells of the locomotive, I found that two wires had short circuited with the drive shaft on the driving bogie. The insulation on the wires had been removed by rubbing on the rotating drive shaft. The red wire was the F1 function and the orange wire is the + supply for all lights.

Solution: - First, I replaced the damaged wires and the AS3 transistor on the circuit board. To stop the motor shaft rubbing on the wires, I cut some clear plastic into a rectangle 21.5x9x0.3mm (LxHxT). Because the plastic is longer than the space it was inserted into it formed a nice bow, allowing the motor shaft on the driving bogie to swing freely and form a barrier so the wires were protected. I also used another plastic strip at the motor end to create the protective barrier between wires and motor shaft.

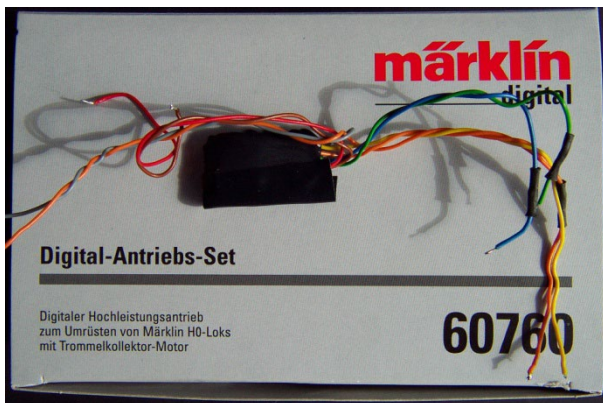
Problem: - The main problem was the locomotive ran very poorly without acceleration/breaking delay being set and even **worse** with the acceleration/breaking delay being set. Every time the loco encountered a power interruption the inertia would start from zero again.

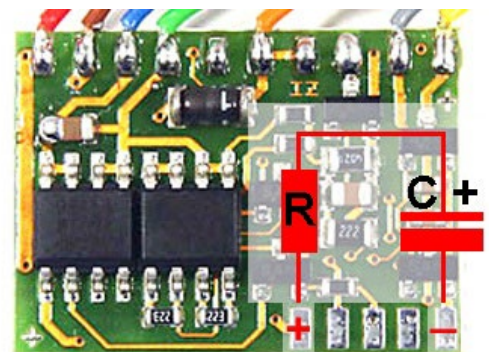
Frustrations: - (just a few) The programming of the CV's (a total of 3) was a problem as Märklin don't state the default settings so I tried a large change to see the results then refined this by halving the last entry until I came close to the correct setting. All in all, this was a very time-consuming process.

Solution: - There is none for this decoder that I can find. I have since pulled out the decoder from the loco and replaced it with a 6090 Decoder that a friend no longer required. My loco now runs like a dream. I will probably use the 60760 Decoder as a lighting decoder only at some further date.

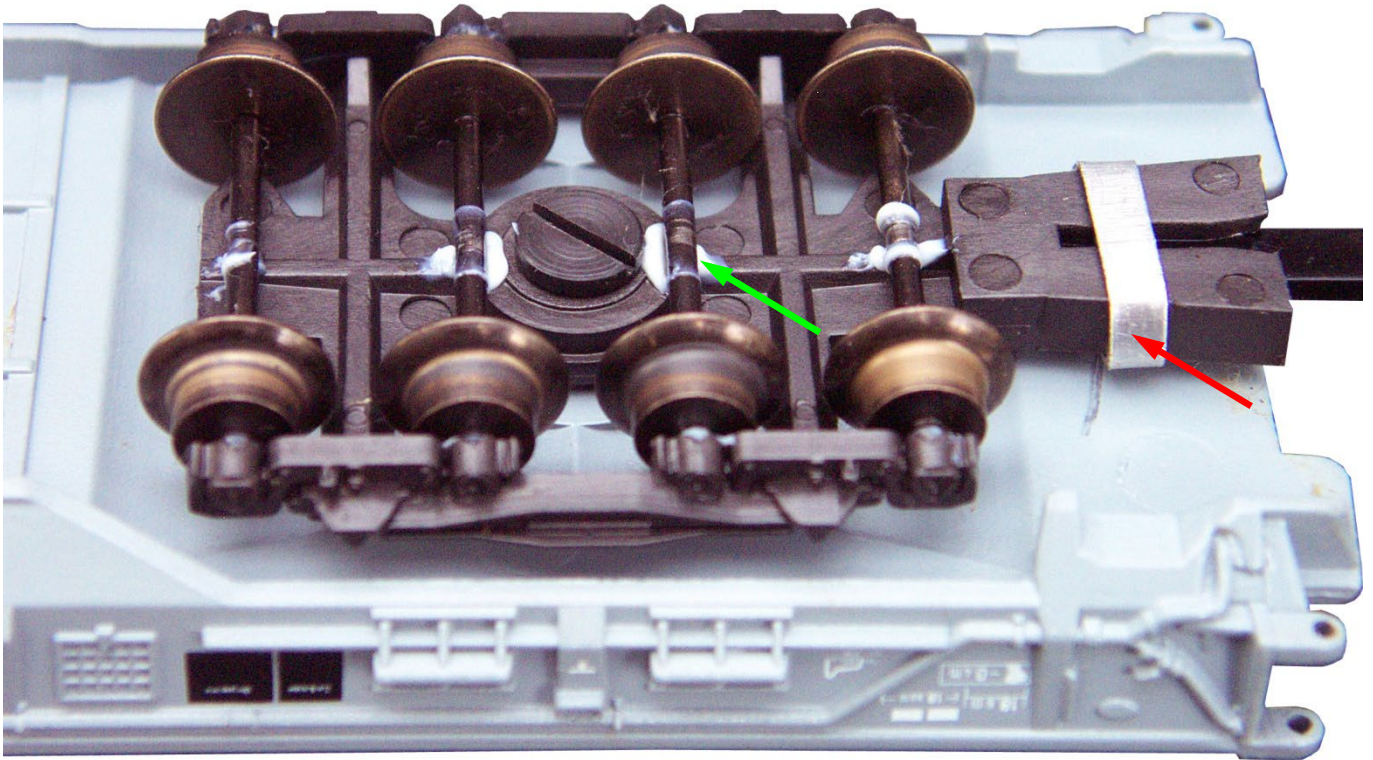
1. Because the flat wagons are all metal and heavy the train started to come apart when going up grades because of the poor coupling design.
2. With a lot of running and normal wear the slumber coach with six flat wagons behind started to uncouple from the loco when the train was climbing a curved grade.

1. I had some flat metal strips which I bent around the coupling to squeeze it together to create a tight grip on the coupling to stop it coming apart (see red arrow).
2. I always lubricate my trains and found that the axles of the flat wagons had started to touch the body of the bogie in the centre of the axle which created more drag on the entire train, just enough to roll the slumber coach over in the curve and uncouple the train from the loco but not enough to leave the tracks. I used Woodland Scenics (HL 657) white grease with Teflon to lubricate the centre of each axle and the problem has gone away (see green arrow).

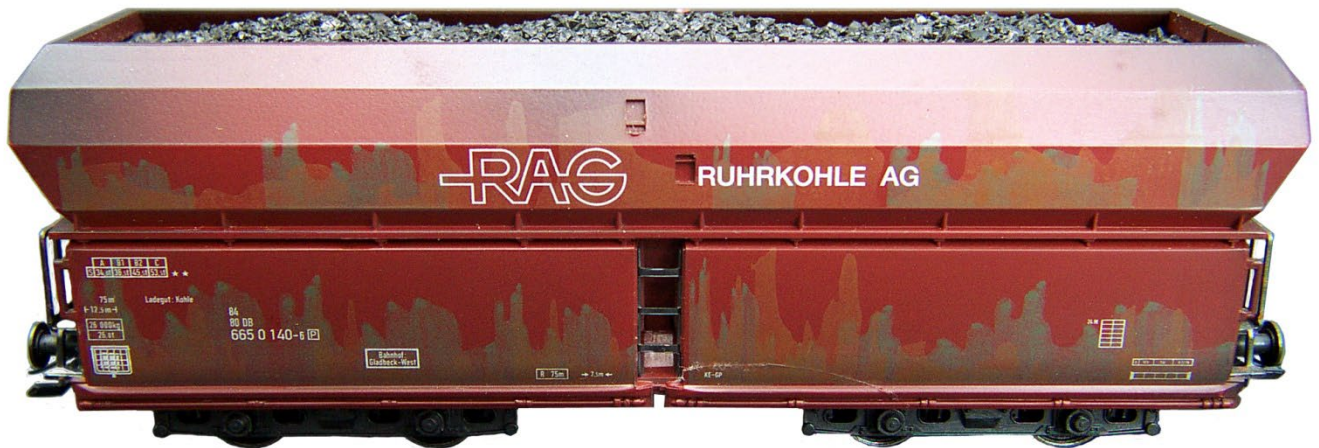
Problem: - Couplings started to jam and throw wagons on any radius curve, this decreased towards the back of the train as the load on the couplings decreased.

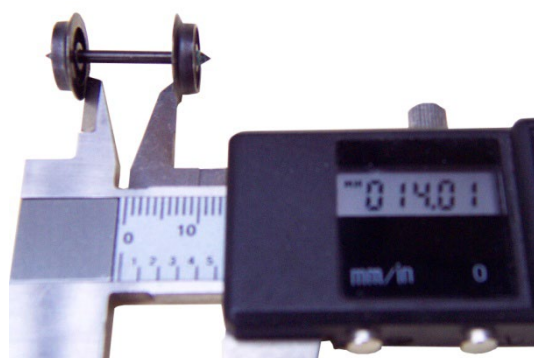
Problem: - The wheel gauge had decreased because of a loose wheel on axle which may have been caused by the wiping action when I cleaned the wheels many times with SR24 Modellbahnöl by Hans Weiss.

Solution: - Was to correct wheel flange dimension 14.00 to 14.1mm and use Locktite to fix in place.

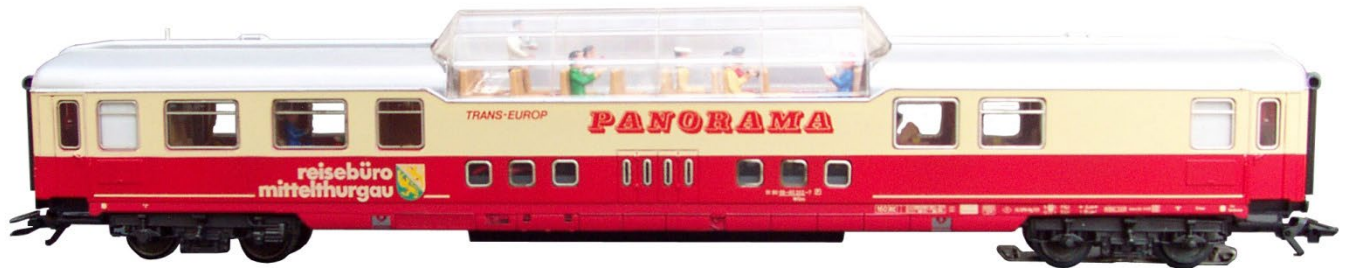
Problem: - After much trial and error, I determined that the collector shoe was to blame. The bronze spring had caused arcing burns to the slider of the collector shoe.

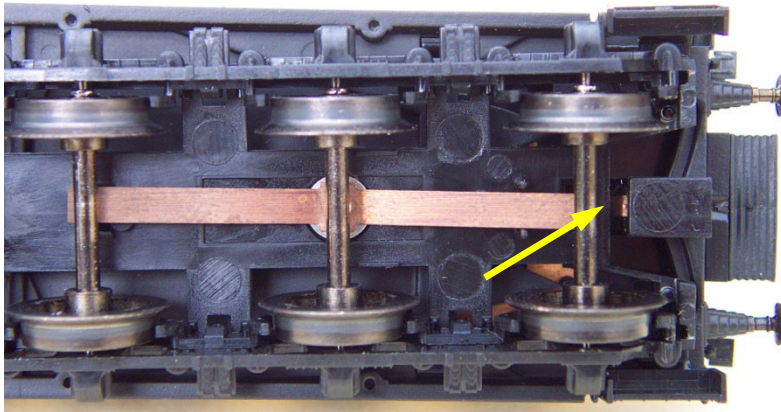
Problem: - I had coupled all the coaches together and turned on all the functions only to find that 2 coaches weren't working. I turned the power off quickly and on closer inspection I found that the copper contact in the coupler pocket had been pushed back so far that the current coupling draw bar was unable to make contact with the copper contact in the coupler pocket. The other contact had come loose from the coupler pocket and was touching the copper ground wheel pickup causing a short circuit

Solution: - I managed to disassemble the two function coaches, straighten the copper contact that goes into the coupler pocket and superglue it back into position in the pocket. Alas I wasn't quick enough to save an output transistor, so I also had to repair the decoder and replace the output transistor. With the wheel contact spring I also trimmed it back so it was as short as possible, to avoid further shorts (see yellow arrow).

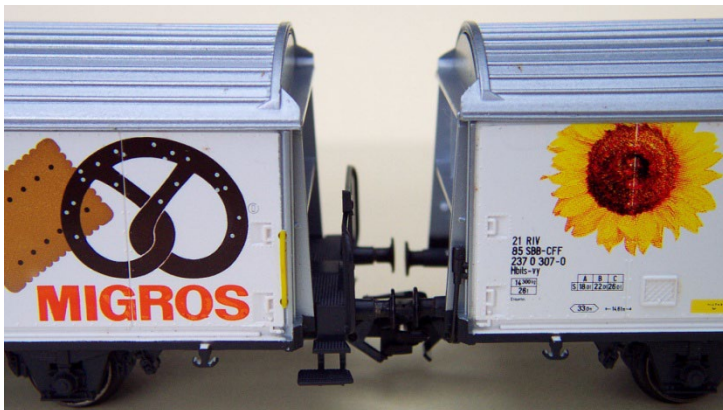
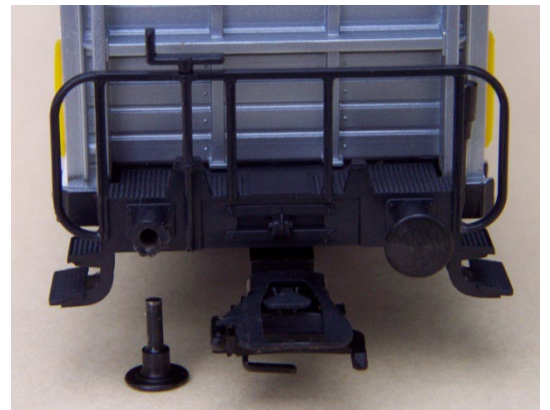
Buffer lock problem 1: - The offending wagons are the Swiss Hbis long wheel base with large overhang eg. 4735, 4834 4835

Solution to problem 1: - There is a metal buffer inserted in the plastic base part of the buffer. I removed the metal insert as it is only a press fit into the plastic and filed .5mm of each plastic part of the buffer then reinserted the metal buffer insert. This mod isn't noticeable even on close inspection.

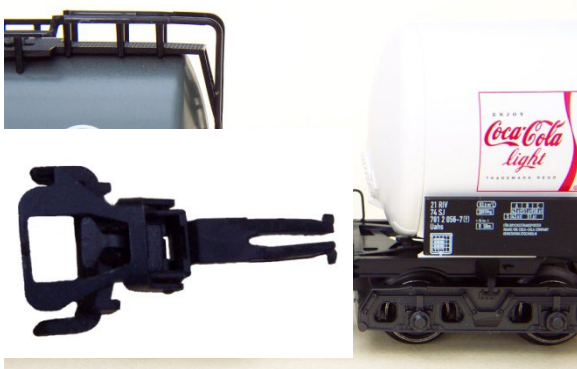
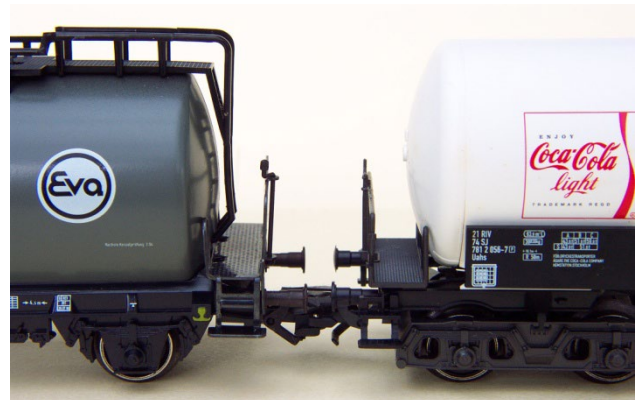
Buffer lock problem 2: - The offending wagons are the long double bogie tank wagons and the short wheel base tank wagons. eg 4644 and 4758. Left photo below standard coupler distance, right showing increased distance after modification.

Solution to problem 2: - Remove the close couplers on the short wheel base wagon. Using spare part 26 3730 (close coupler used on several locos) cut off the pivot stubs and trim the plastic spring back to about 1mm in length. Then using a fine saw cut a slot about 5mm down the stem of the coupler (see below).

Insert modified coupler into the coupler pocket. The 26 3730 coupler is about .75mm longer than the 70 1630 standard close coupler, just enough to overcome the buffer lock.

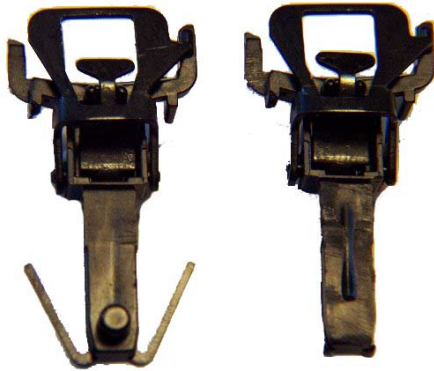
Problem: - On a 360mm radius curve the 460-class loco would derail the trailing wheels of the first coach. It would flick the coach off the rails as the loco entered the curve. I noticed that the couplings caught on the buffers and wouldn't allow full movement of the couplings.

Solution: - First, I removed the buffers from the loco, this worked but didn't look very good. I next tried a current conducting coupler, this worked but is no good if you don't want a fixed train composition

Using spare part 26 3730 (close coupler used on several locos) cut off the pivot stubs and plastic springs. File the pivots and springs flat then insert the coupling into the coupler pocket. The fit should be tight. Next adjust the length approx. 1.8 to 2.2mm longer than the standard coupler. This extra length will just clear the rear of the coupling from the buffer and looks fine.
